Remedial action for incorrectly cast-in channels

Published Date: 10/12/2009

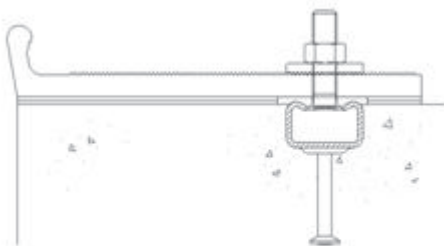
SECTION

Channels that have been installed and are raised from the surface of the concrete will have an unsupported section of the channel side walls. This will allow a possible increase of deflection at the channel lip when under load.

Acceptable Limits

Provided that the projection is no more than 5mm then the channel will still be able to take the full channel load without any requirement for remedial work. However it will be necessary to check that the fixing bracket still has the required bearing area and that any shims required are installed in an acceptable method

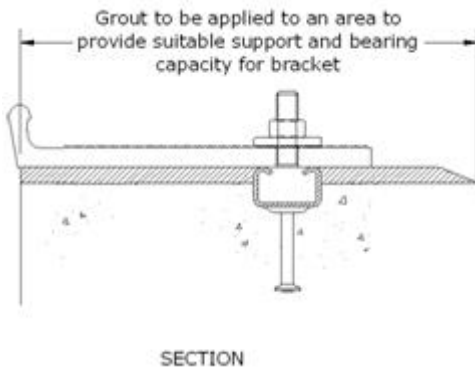
SECTION

Beyond Limits

If the channel is projecting more than 5mm but no more than 2/3 the overall depth of the channel then the following remedial work must be undertaken:

High strength, non shrink grout must be applied to and built up around the channel from the front edge of the slab deck extending back to a distance of 100mm minimum beyond the bracket to the rear of the channel and a minimum of 50mm beyond the ends of the channel, up to the depth required to fully embed the channel. This new grout surface will need to be flat and level to allow the bracket to have full bearing to the underside of the bracket.

J&P Building Systems / Jordahl® recommend the use of Pagel EH2 or Hilti CM 510-1 epoxy mortar. It is possible to use a different manufacturer and type of grout but users should satisfy themselves that the grout to be used gives the same performance as the recommended types. The grout manufacturer's recommendations must be followed.

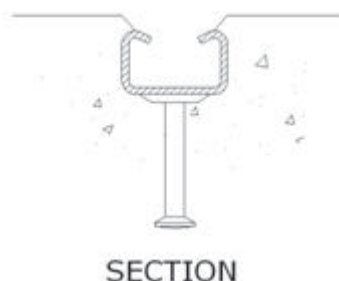
Channels that have been installed and are sunken below the surface of the concrete will not suffer any direct performance penalties, however as there is an area of unsupported bolt shank it may introduce bending in the bolt that may not have been allowed for within the initial design.

Tee Bolts are able to accommodate a degree of bending moment and this information will be available in the supplier's catalogue.

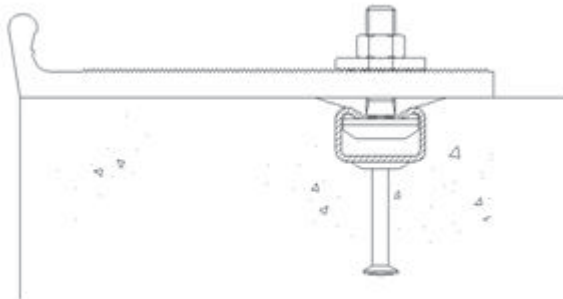
Acceptable Limits

Provided that the gap between the top of the channel lips and the underside of the bracket is no more than 5mm, the channel and bolts will remain able to take the full load without any need for remedial work.

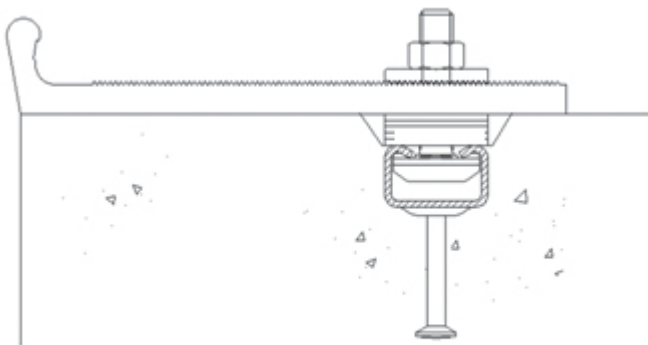
SECTION

Beyond Limits

If the channel is more than 5mm below the concrete surface then the following remedial work must be undertaken:

Rectangular plate washers must be placed over the bolts to fill the gap between the surface of the channel lips and the underside of the bracket. This is to provide support to the bolt shank to prevent bending. Before washers are introduced the channel lips must be fully exposed in the bolt locations to ensure that the washers sit directly on the channel lips. The washers should not project above the concrete surface level.

It is recommended that only one washer is used, or alternatively a maximum of 3 washers welded together to a maximum recess depth of 15mm. It has to be ensured that the washers are a tight fit between the side faces of the recess to prevent transverse movement.

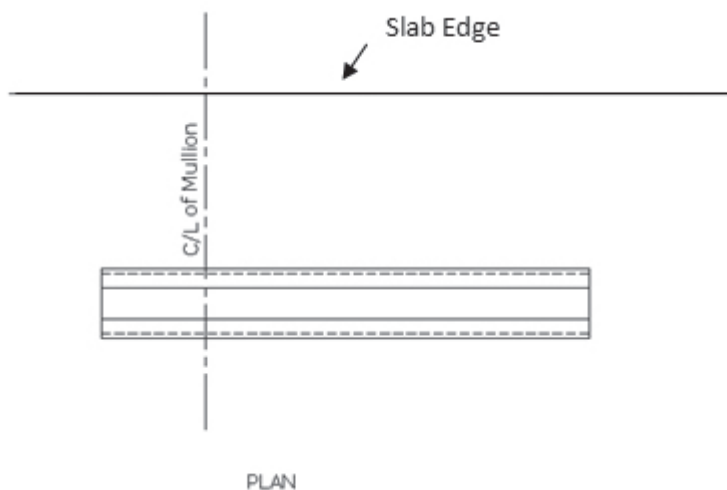
Channels installed out of alignment to the intended position in the horizontal plane, so that the centre line of the load is no longer central on the channel. When the bracket is installed one, or in extreme circumstances both, bolts miss the channel.

This tolerance issue does not directly affect the performance of the channel unless one or more of the other described cases is also present. It is therefore the decision of the Contractor how to approach and resolve this situation. However it is recommended that, if additional bolts are required, then it is best to drill right through the slab and fix with a plate on the underside. This will negate the effect of additional forces due to post drilled expansion / resin fix bolts disrupting the cast in channel.

In the case of both bolts falling outside the cast in channel then it is recommended that the fixing bolt manufacture is made aware of the channel location as this may affect the performance of any specified bolts.

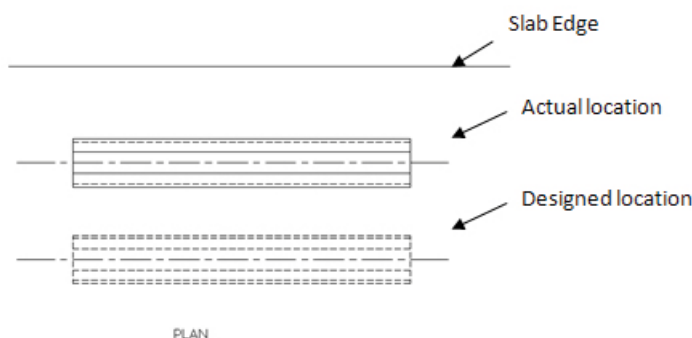
Channels installed too close to slab edge, reducing the design edge dimension below the minimum recommended. Channels that are cast too close to the slab edge may have reduced load capacity.

The reduced edge dimension may still be acceptable relative to the design loads, provided that the individual application load still falls within the reduced edge distance concrete capacity. The channel supplier can provide substantiation in these individual situations.

If the design parameters from the channel supplier show that the edge dimension is below the minimum required dimension to achieve the required load capacity, then other remedial post drilled measures will be necessary.

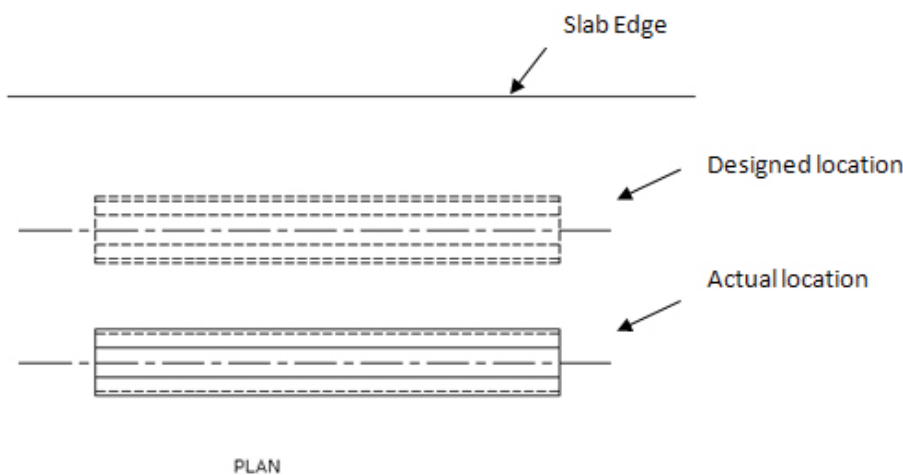
Channels installed too far back from the slab edge will not have a direct impact on the channel performance as the minimum edge distance will be maintained.

This tolerance issue does not directly affect the performance of the Jordahl® channel unless one or more of the other described cases is also present. It is therefore the decision of the Contractor how to approach and resolve this situation.

The tolerance within the bracket arrangement will have a limited capacity. Once this has been exceeded then it may be considered similar to Case 3 and therefore the recommendations made for Case 3 should be followed.

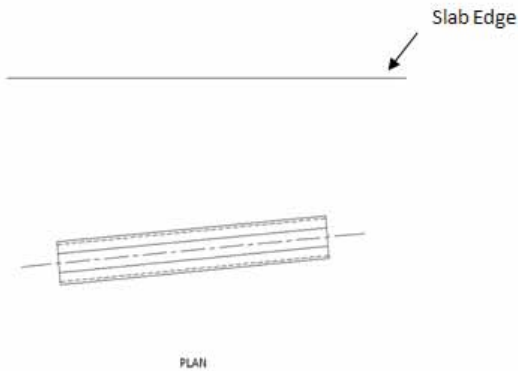
Channels are installed out of horizontal alignment with the slab edge, and therefore no longer parallel with the slab edge. If no measures are taken, the connecting bolts or studding can be put into a bending condition.

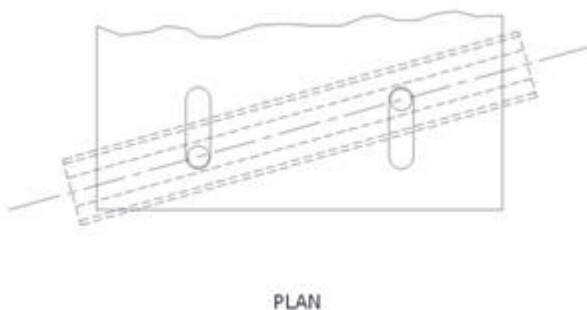
Provided that the closest edge of the channel does not fall below that described in Case 4 then this tolerance issue does not directly affect the performance of the channels unless one or more of the other described cases is also present. It is therefore the decision of the Contractor how to approach and resolve this situation.

The distance between the slots in the bracket and the length of slots will determine the maximum angle the channel can be out of alignment.
