**Reinforcements at large openings**

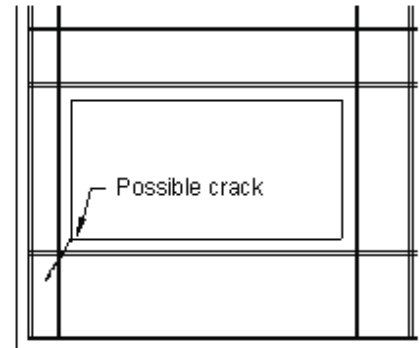
Design steel as per calcs  
(main bars only shown)

In general, unless there are special circumstances, the above bars would not be 'designed' and would not appear on a simple design calculation. They should however always be shown on drawings.

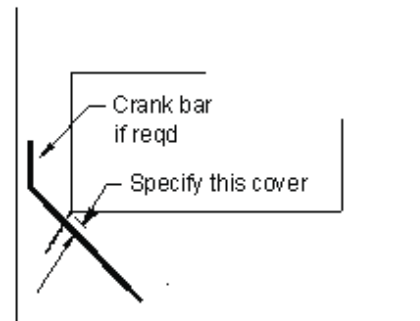
Corner bars to stop cracks  
(1 per face)

These cracks are most likely to start at the corner and go at approx 45° as shown. The most common reason for these is due to handling stresses during demoulding, as well as racking during transport/handling.

To control corner cracks, bars should be detailed as shown across the corner of the opening.

They should be at 45° as shown to be as efficient as possible in stopping the crack and at least an anchorage length each side of the crack position. The diameter should be assessed relative to the size of the panel, and is typically the same size as the bars trimming the opening elsewhere.

It is most important that the cover to the corner of the opening is the minimum allowed by the specification.

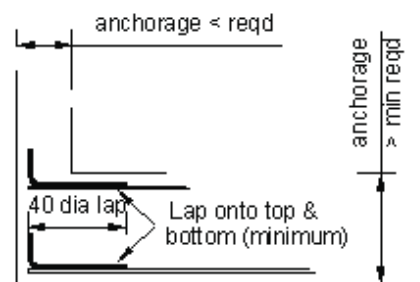
Corner bars to anchor main steel  
(1 per face)

Corner bars to anchor main steel  
when reqd in both directions

If the general horizontal or vertical bars do not have the required lap/anchorage beyond the opening then additional bars should be provided to compensate. A simple 'L' bar as shown will be sufficient in most cases. Such bars must never be detailed with the bend at the corner of the opening as this could burst out under load.

The diameter should be the same as the bar it laps onto, with an anchorage bend as required.
